Influence of Subsurface Details on
Braced Excavations in Puerto Rico
Alan R. Crumley, F. ASCE ¹

This is a condensed version of a paper presented at the ASCE National Convention in October, 1998 at Boston.

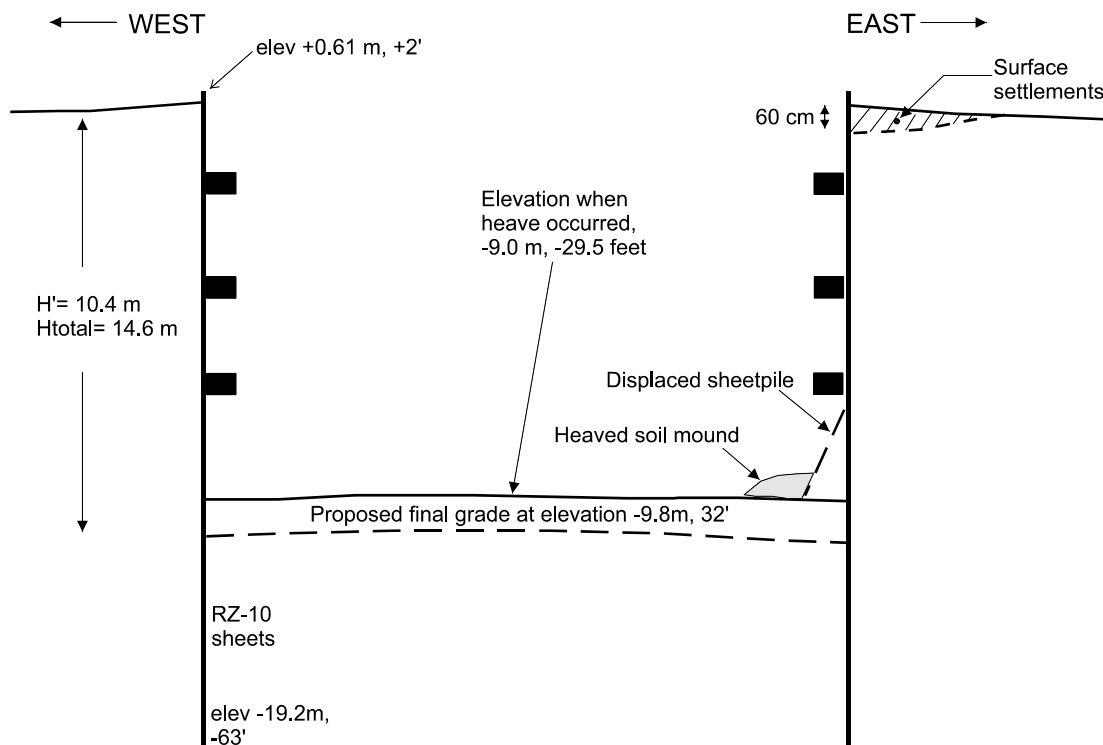
Figure 2. Cross-section of the Circular Cofferdam

Substantial inward movements of the second set of sheetpiles occurred at a location just below the third ring, after excavation to elevation -9.0 meters (-29.5 ft) in preparation for construction of the fourth ring. These movements occurred over a weekend. The east side of the cofferdam appeared to have been lifted as the sheetpiles moved inward, hinging about the bottom of the third ring. At this level, it was evident that the sheets had moved inwards at least 1.5 meters (5 ft) and were inclined roughly 2V:1H. The area behind the zone of movements had settled on the order of 60 centimeters (see Figure 2). It was also apparent that the top of the sheets in this area was lower than when originally driven. In addition, some settlements of the concrete compression rings had occurred towards this area.

Thereafter, the excavation bottom at -9.0 meters (-29.5 ft) was backfilled by the contractor to elevation -7.6 meters (-25 ft). Nevertheless, movements of the rings and the sheetpiles continued for several days. These movements consisted of settlements of the rings and tops of sheetpiles (about 13 centimeters), and separation of the uppermost lengths of sheetpile from the first ring (particularly at the east side), as if they were tilting away from the compression ring

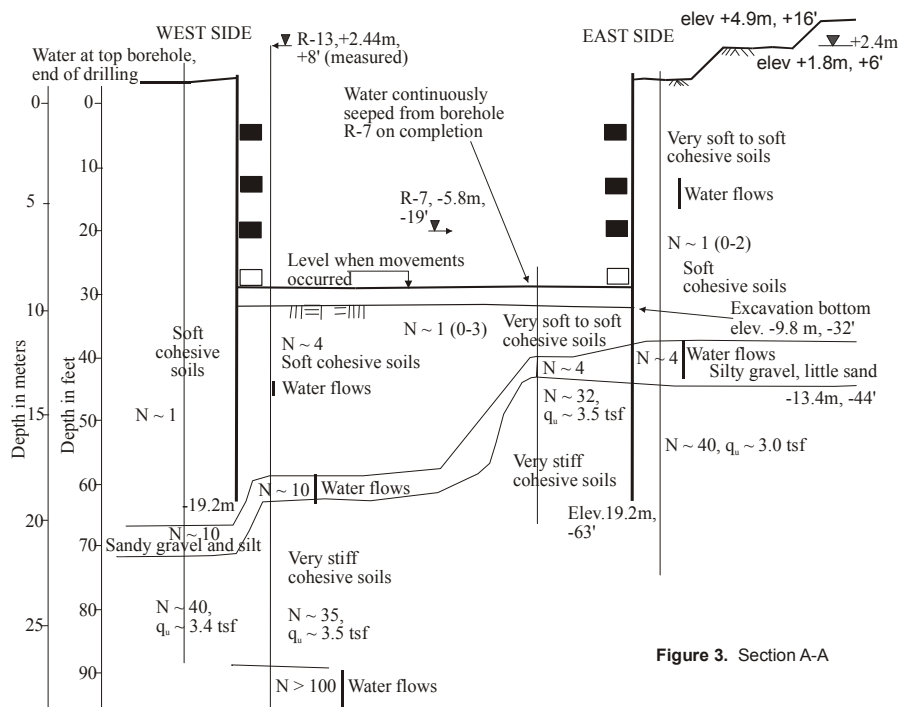
Figure 3. Section A-A

During both construction designs (the first and second cofferdams), it had been assumed that the underlying strata were continuous and that the various strata were uniformly distributed. The foundation design before the bid had been based mainly on two nearby borings; these boreholes were drilled using 1.5 -meter ($5'$) sampling intervals. The borings drilled after the movements occurred, within the affected zone, showed that the sheetpiles were embedded in hard soils; a cause for these movements was not readily apparent. Thus, a boring was drilled at the northwest periphery where no movements had been recorded. This boring presented a different layering sequence. Soft soils were found to elevation -18.6 meters (-60.9 ft) and the tip of the sheetpiles was shown to be barely into a medium silty clay layer. Beneath this layer and below the sheetpile tips, there was a 1.5 -meter-thick (5 ft) layer of sandy gravel and silt down to elevation -20.9

meters (-68.4 ft), followed by the very stiff silty clays also found in other borings. Surprisingly, the bottom of the sheets was not seated into the underlying hard clays, as indicated on Figure 3, West Side.

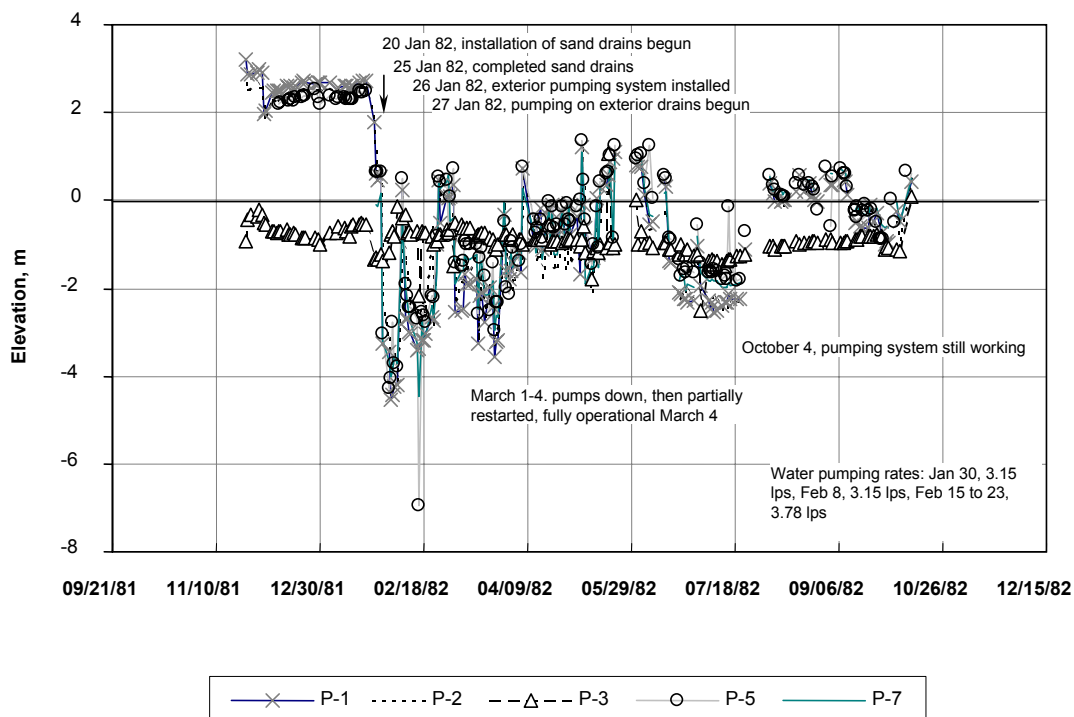
Figure 4. Piezometers Inside Circular Cofferdam

Seven (7) piezometers and one (1) observation well were installed. Interior relief wells or drains were installed inside the excavation. The interior water levels were near elevation -5.8 meters (-19 ft). Figure 4 is a graph of water pressures from the date of the failure until shutdown towards the completion of foundation construction for this structure. The interior sand drains were passive relief wells, 15 cm (6 in) holes drilled to depths of 11.3 meters (35 ft) inside the east side of the excavation and filled with sand and gravel, with 2-inch-diameter (5 cm) PVC casings, at typical spacings of 4.5 meters. Water flowed from these drains and was collected in sumps, as water levels inside the cofferdam decreased.

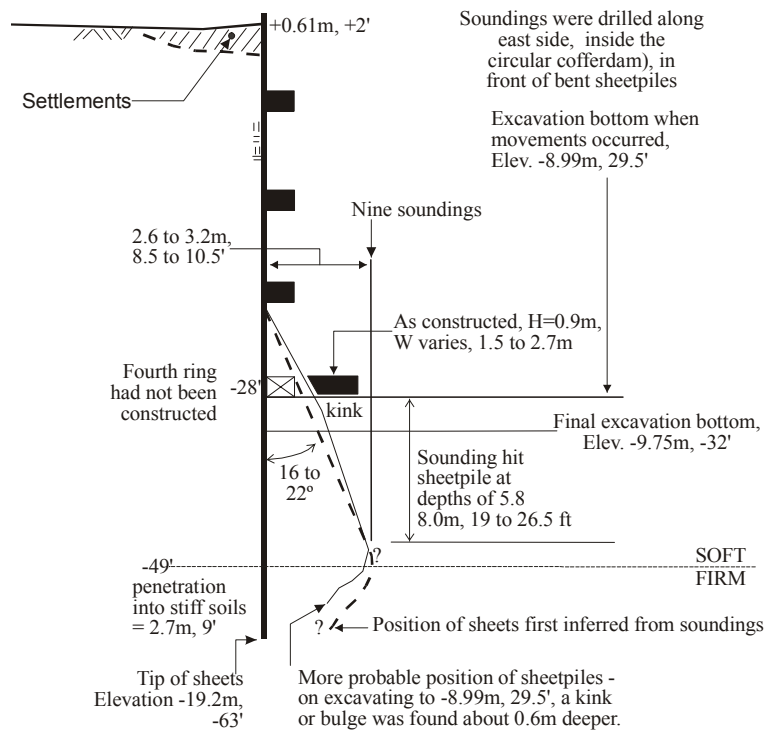
Figure 5. Displaced Sheetpiles, According to Soundings

Soundings drilled within the second (circular) cofferdam confirmed that the tips of the sheets moved inward; the soundings were drilled until metal was encountered. The soundings indicated lateral inward movements, as shown on Figure 5. Much later, after excavating for the fourth ring, it was shown that the sheets had a kink or bulge about 60 centimeters below the bottom of the excavation at the moment when movements occurred. This kink was in the reverse direction from the inward movements. The inverse direction of the kink indicates that the tip of the sheetpile piles

did not rotate inward in a circular failure arc within a slipping or sliding soil mass. Strain-gauge readings taken throughout the life of the project, from instruments installed by the structural designer within the concrete rings, indicated that loads to the compression rings did not exceed the design loads.

With the subsoil information obtained, it was concluded that the movements were caused by uplift of the inner soils lying above the granular layer. The movements occurred after uplift of the inner soils, causing loss of interior support to a substantial length of the sheetpile. The exterior forces would continue to act; the sheetpile would have to move inward due to its inability to resist such excessive unbalanced forces. Bending of the sheetpile would begin to occur somewhere below the third ring. Further below, the sheetpile tip was in hard clay. Eventually, the sheetpile would move, either by rotational displacement of the tip or by being pulled from its clay socket. The presence of the kink or bulge previously mentioned (Figure 5) confirms that movements occurred in this sequence, after the bottom soil was uplifted.

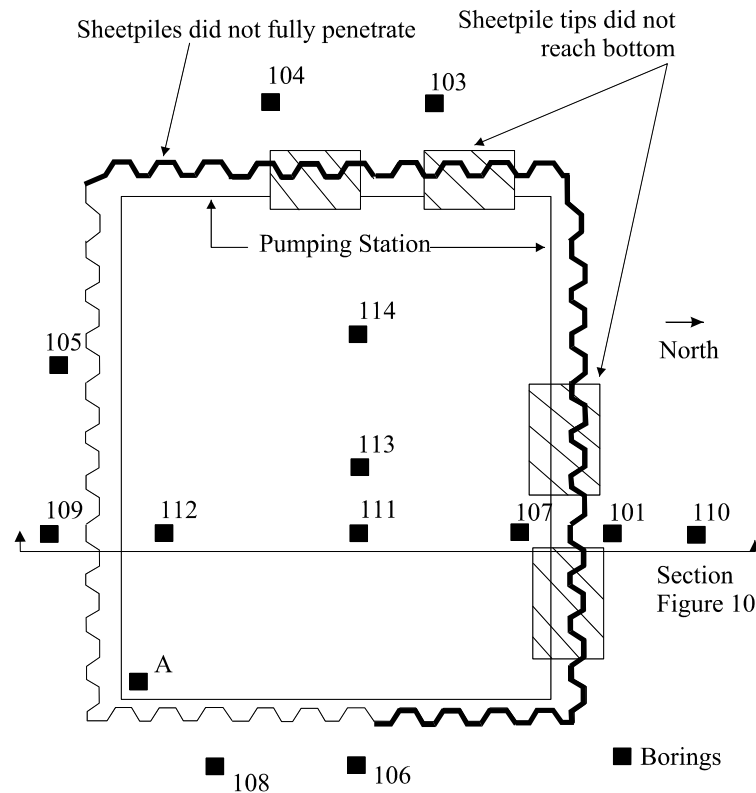
Figure 7. Sheetpile excavation

sides of the excavation the sheets did not penetrate fully and in some instances did not even reach the bottom of the excavation. The piles were redriven using a Link Belt 520 hammer (35.9 kN.m or 26,500 ft-pounds) but additional penetration was minimal, never exceeding 1.5 meters. One of the sheets was pulled and showed excessive damage at the tip. However, at other areas (east and south) the piles were easily inserted and reached the 18.3-meter depths using the same vibratory hammer (see Figure 7). The shallow sheetpile penetrations were unexpected and particularly worrisome, since lack of embedment below the excavation bottom could lead to instability.

Thick sheetpile line indicates areas where sheetpiles did not fully penetrate.
 Hatched zones indicate areas where sheetpile did even not reach excavation bottom.

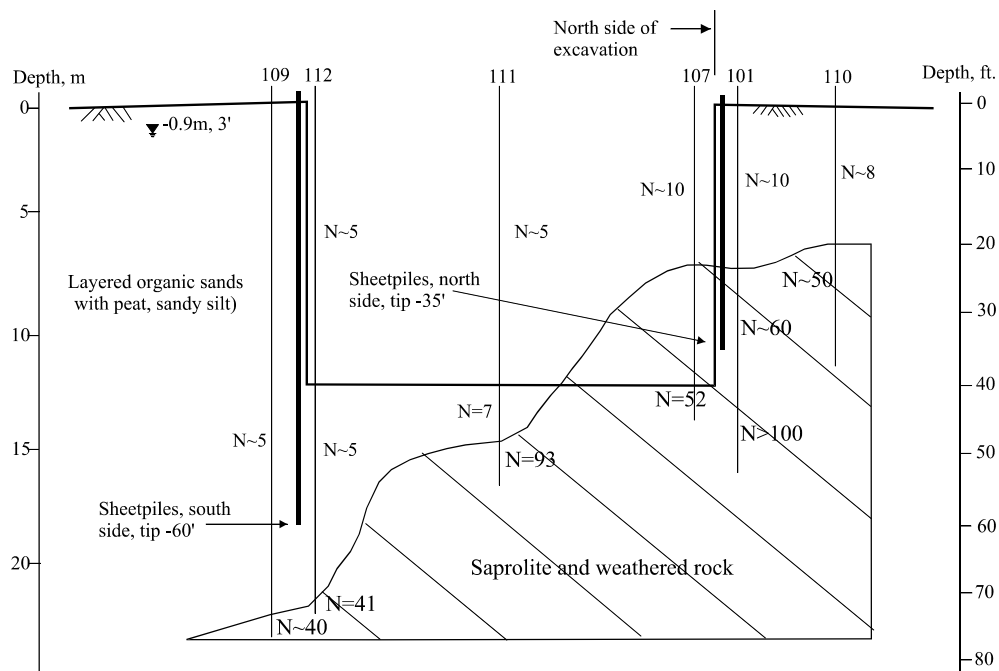
Figure 8. Actual Subsoil Profile

Additional borings were drilled along the sides of the excavation. Figure 8 shows the subsoil profile obtained after the last investigation. The saprolitic material from weathered volcanics clearly varied in depth throughout the site, from 9 meters on one side to 22 meters on the other. Clearly, one side of the excavation would enter the saprolite or weathered rock, whereas the other side of the excavation would still be in soft soils. To the north, the sheets could not penetrate to the excavation bottom, whereas to the south, the sheets sank their full length under a vibratory hammer.

Lateral pressures on each side of the excavation would vary and cause uneven displacements, given the variations in depths of soft and loose soils. Since there were no nearby structures, uneven displacements and surface settlements did not concern us. Stability of the excavation was another concern, as some of the sheets did not reach the excavation bottom (Figure 8). On inspection of the saprolite samples, it was observed that the weathered rock was massive and would perform as an impervious mass, similar to a clay soil, notwithstanding the fact that the samples, once recovered, behaved as friable silts. Water was not expected to flow freely through this soil which retains many characteristics of the parent rock. The short term strength of the saprolite was undoubtedly high; experience in these soils indicates that the undrained cohesive strength is not lost with time or is available for a long time, possibly due to cementation.

The excavation was taken to the bottom and successfully completed. At one of the locations where the sheets did not reach the excavation bottom, a large flow of water did develop just above the saprolite and under some sheets which had split open at the bottom due to heavy driving. After flooding the excavation, these flows were sealed by driving additional sheets just behind this zone. The saprolite held up extremely well and water flows through this material did not develop. The lower saprolitic soil performed as a hard cohesive material and a stable excavation was achieved. Nonetheless, an excavation which first appeared to be a textbook case, actually confirmed the well-known yet often-unheeded observation that subsurface conditions can change

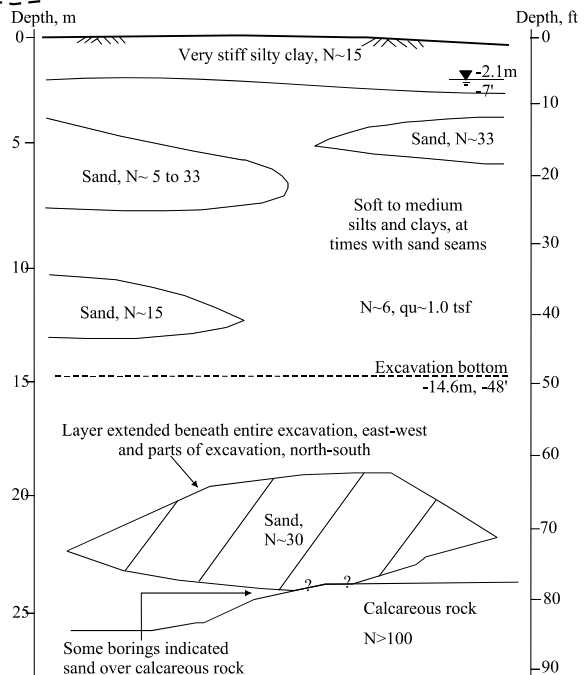
Figure 10. Subsoil Profile

borings also revealed the presence of a layer of clean medium to coarse sand within the stiff clay, as shown in Figure 10.

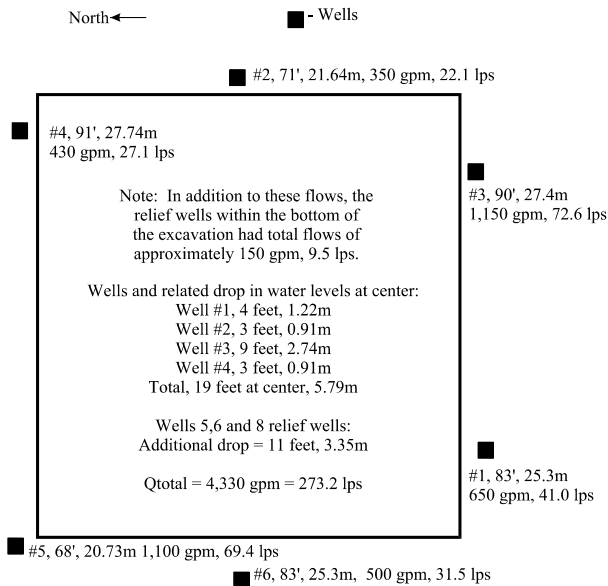
Figure 12. Wells and Pumping Rates

than the width of any soil plug. Assuming a confined layer, it was calculated that pumping 88 lps (1,400 gpm) would be required for reduction of the water pressure by 8.5 m (28 ft), so that the soil weight was the same as the uplift pressure. Four deep wells were installed as shown on Figure 12 but were not overly effective. The construction of the wells was highly suspect, due to inappropriate well screens with low entrance areas and doubts regarding installation of the well gravel packs, particularly their location with respect to the pervious layers and their thickness. Erroneous permeabilities could also

have been obtained from an initial pumping test on the first deep well, or the sands and calcareous soils below could be interconnected. Nonetheless, in spite of the wells, piezometers in the center of the excavation showed that drawdown was only 5.8 m (19 ft) whereas 8.5 m (28 ft) were required to avoid blowup.

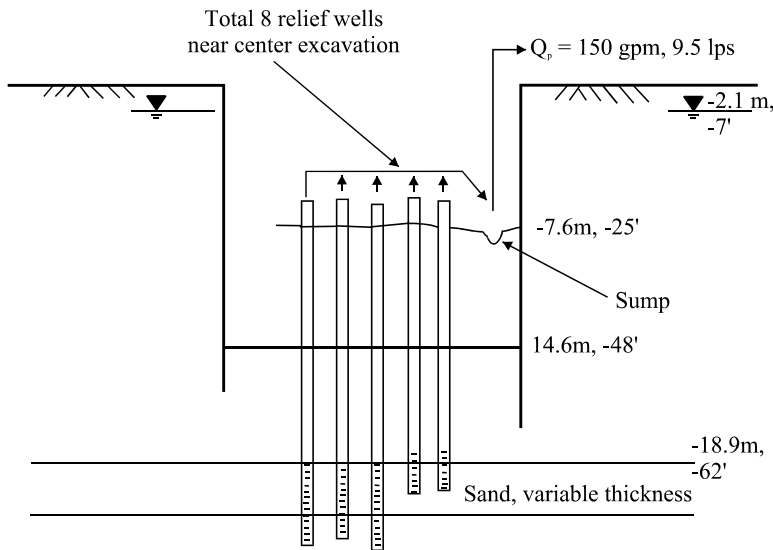
Figure 13. Relief Wells Within Excavation

Wells(8) installed on reaching -25 ft, -7.6m. The water sump was moved as excavation proceeded. Wells were passive wells and water flowed without pumps from pipes and onto ground through gravel working mats to sumps.

a series of passive relief wells within the excavation bottom, taking these wells to a sump (Figure 13) with two additional exterior deep wells (#5 and #6). The pressure then dropped below the required levels (to -9.1m, -30 ft) and the excavation was completed. Pressure relief was immediate as the passive wells were installed, since they were located in what is undoubtedly the most effective location, near the excavation center.
