Influence of Subsurface Details on
Braced Excavations in Puerto Rico
Alan R. Crumley, F. ASCE ¹

This is a condensed version of a paper presented at the ASCE National Convention in October, 1998 at Boston.

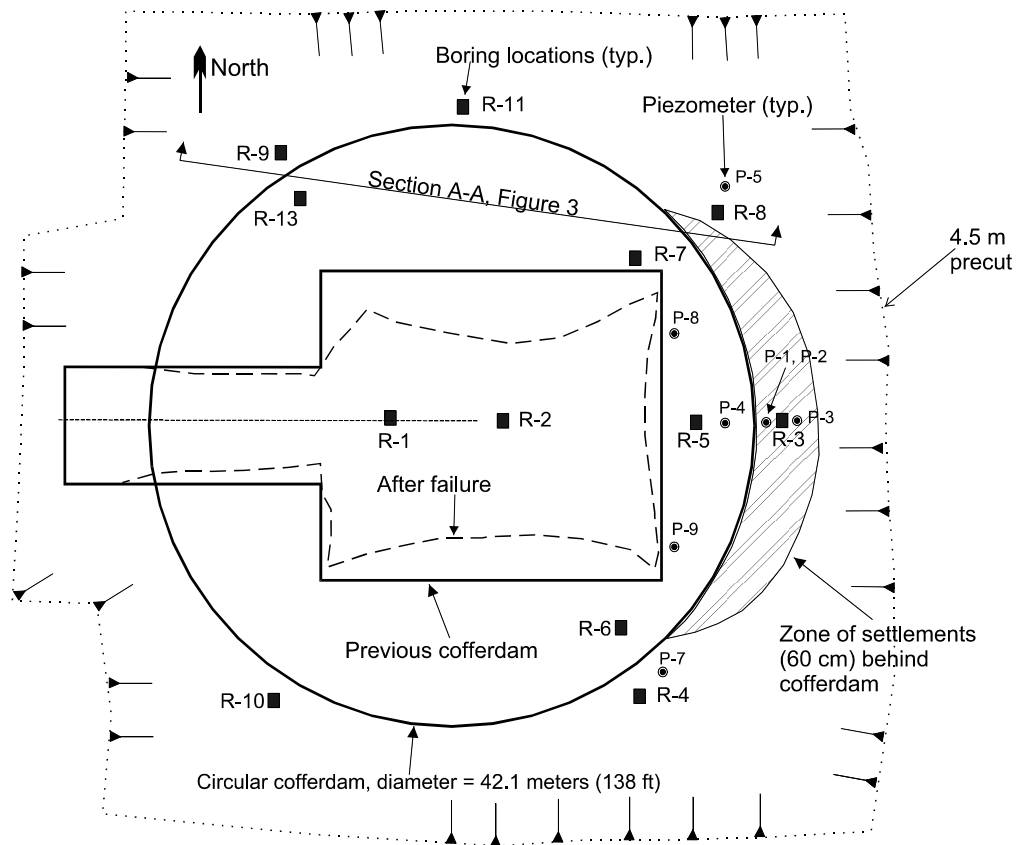
Figure 1. Plan View

Substantial inward movements of the second set of sheetpiles occurred at a location just below the third ring, after excavation to elevation -9.0 meters (-29.5 ft) in preparation for construction of the fourth ring. These movements occurred over a weekend. The east side of the cofferdam appeared to have been lifted as the sheetpiles moved inward, hinging about the bottom of the third ring. At this level, it was evident that the sheets had moved inwards at least 1.5 meters (5 ft) and were inclined roughly 2V:1H. The area behind the zone of movements had settled on the order of 60 centimeters (see Figure 2). It was also apparent that the top of the sheets in this area was lower than when originally driven. In addition, some settlements of the concrete compression rings had occurred towards this area.

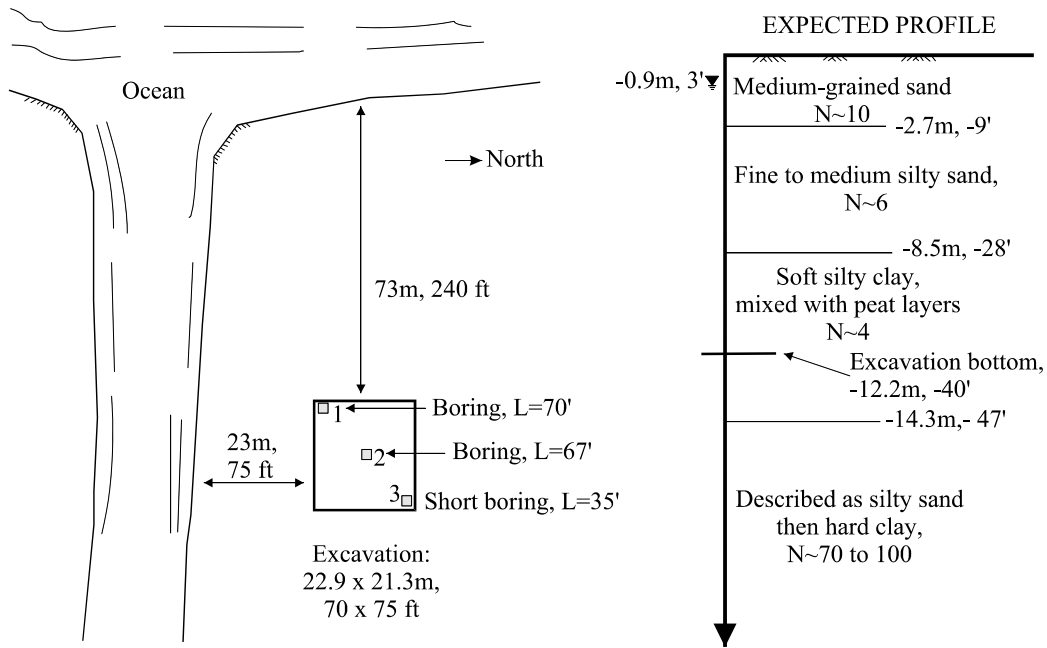
Figure 6. Location and Expected General Profile

The excavated area was to be 22.9 by 21.3 meters (75 x 70 ft). The pump station was sited 73 meters from the ocean and 23 meters from a small river on another side. Three borings had been drilled during design on a diagonal line across the proposed structure, as shown on Figure 6; they showed loose silty sands to depths of 12 meters with interlaying soft soils, including a 1.5-meter layer of peat. On award of the bid and based on the design borings, the contractor had purchased 18.3-meter (60 ft) sheetpile sections (Larssen II-S, 70 kg/m). They were initially driven with a vibratory hammer (LB Foster 275E).

sides of the excavation the sheets did not penetrate fully and in some instances did not even reach the bottom of the excavation. The piles were redriven using a Link Belt 520 hammer (35.9 kN.m or 26,500 ft-pounds) but additional penetration was minimal, never exceeding 1.5 meters. One of the sheets was pulled and showed excessive damage at the tip. However, at other areas (east and south) the piles were easily inserted and reached the 18.3-meter depths using the same vibratory hammer (see Figure 7). The shallow sheetpile penetrations were unexpected and particularly worrisome, since lack of embedment below the excavation bottom could lead to instability.

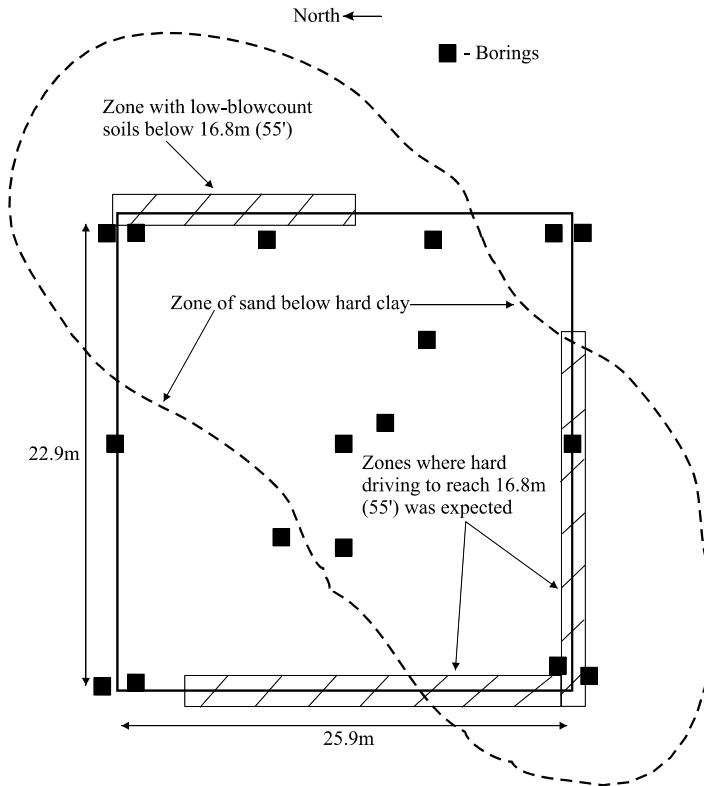
Figure 9. Plan View

A pumping station was to be constructed, with the excavation sized at 22.9 by 25.9 meters (Figure 9). The excavation depth was 14.6 meters (48 ft) and water was found at a depth of 2.1m (7 ft). Six borings were drilled during design using standard 5-foot (1.5-meter) sampling intervals. They revealed soft soils overlying a calcareous basement, and did not penetrate deeply into the stiff materials. Borings drilled during the excavation design using continuous sampling showed soft soils to depths of 14.6 meters (48 ft) with several layers of sand. Below this depth, the soils consisted of stiff to hard clays, followed by the calcareous rocks. However, some of the

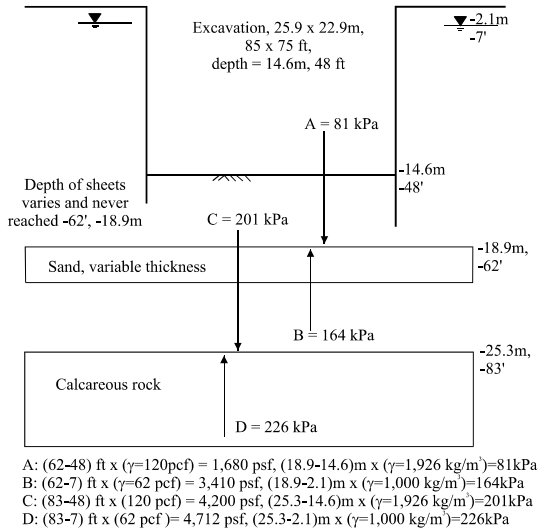
Figure 11. Blowup Formulation

Piezometers did not indicate pressures which greatly exceeded the general phreatic surface. However, the presence of a trapped aquifer was cause for concern as the excavation bottom would lie near the sand layer. Since sheetpiles could not penetrate the hard clay layer to seal against water flows, water pressures could blow the excavation bottom, as the weight of the soil plug was less than the probable water pressures (shown on Figure 11). While the sand layer did not extend over the entire area, the pressures were sufficiently unbalanced so that blowup was cause for concern.
